**REMOVAL PROGRAM  
AFTER ACTION REPORT  
FOR THE  
PARSONS PAPER MILL SITE  
HOLYOKE, HAMPDEN COUNTY, MASSACHUSETTS  
16 NOVEMBER 2009 THROUGH 26 APRIL 2010**

Weston Solutions, Inc.  
Superfund Technical Assessment and Response Team III (START)  
3 Riverside Drive  
Andover, Massachusetts 01810

August 2010

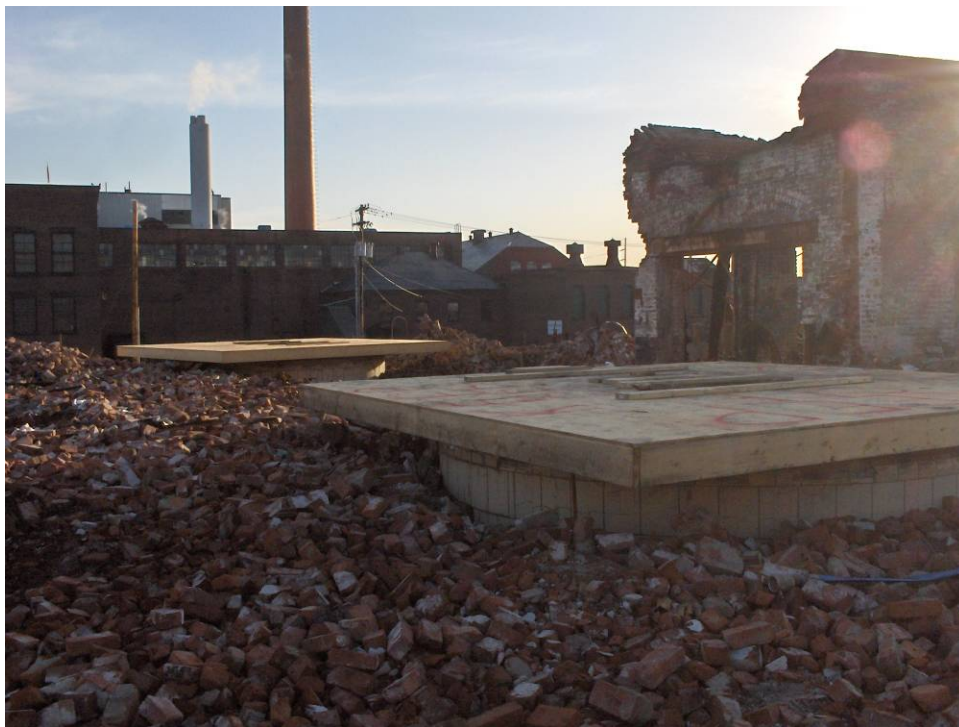
**SCENE:** View of the ceramic basins that were exposed after demolition work and covered for safety at the end of the removal project. Photograph taken facing northeast.

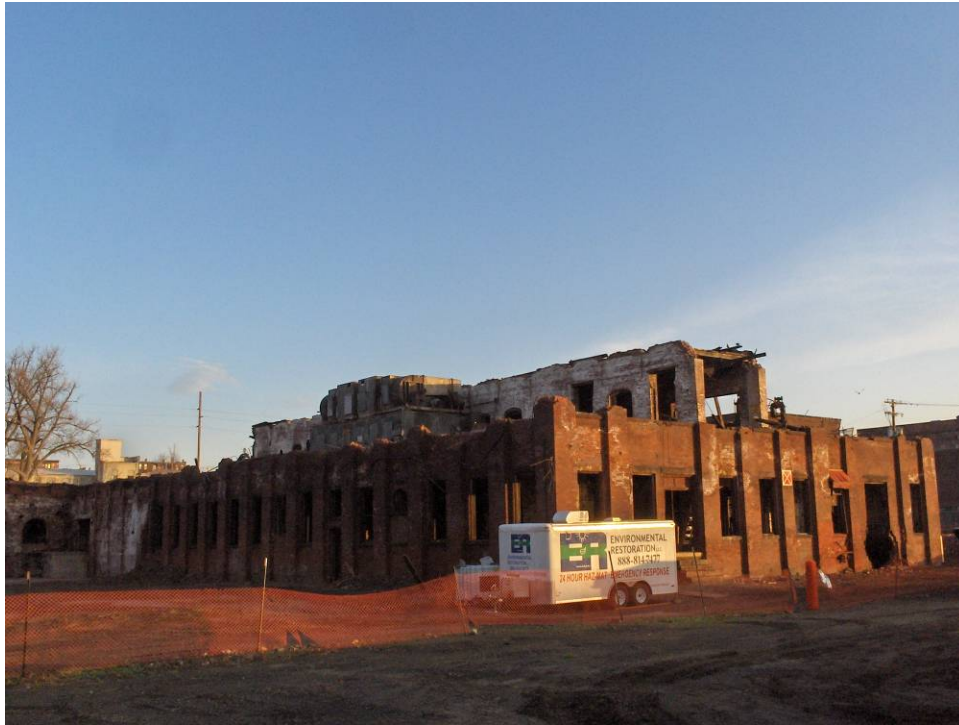
**SCENE:** View of Building No. 3 following all demolition and ACM removal. Photograph taken facing north.

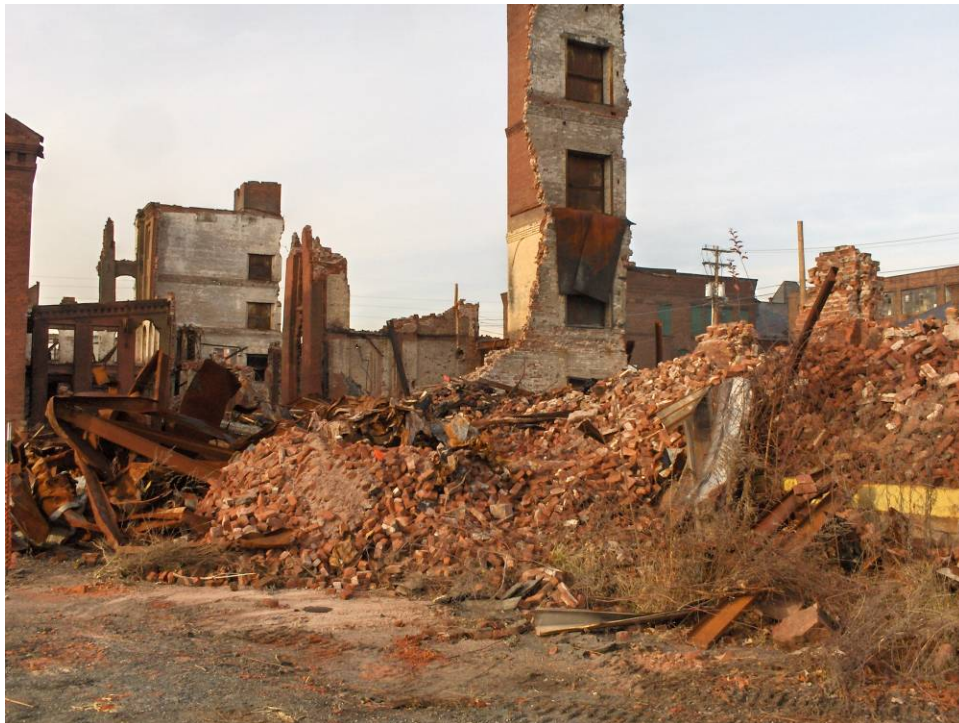
**SCENE:** View of the remains of Building No. 4 at the start of the removal project. Photograph taken facing north.

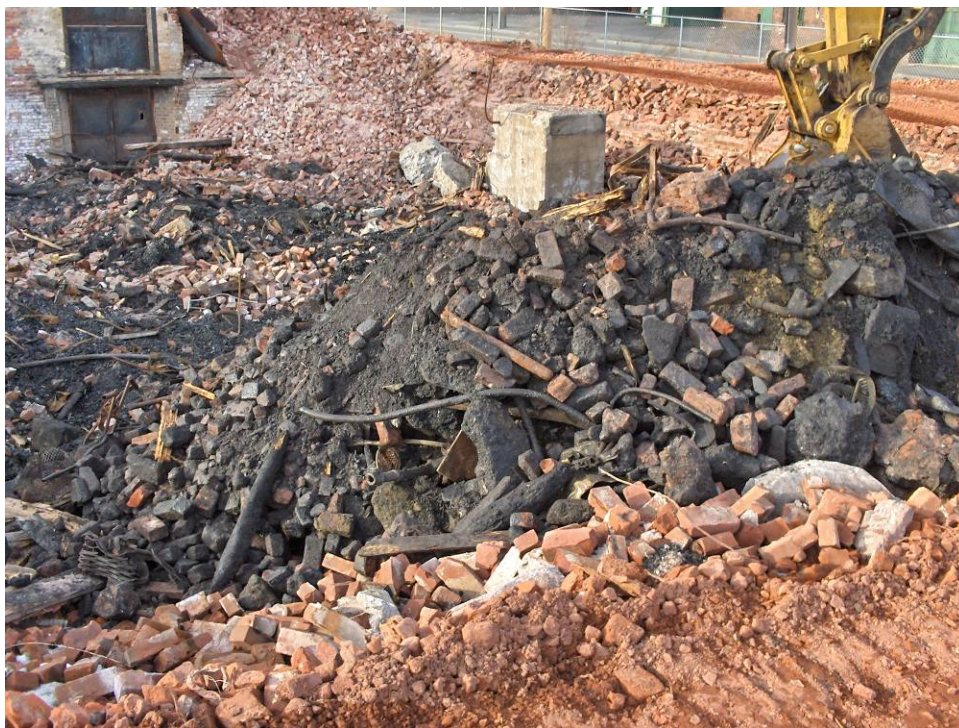
**SCENE:** View of the ACM debris stockpiled for load out from the contaminated areas of Debris Samples 7,8,13, and 17.

- Conducting perimeter air sampling.
- Removing scrap metal from around and within the old foundation of Building No. 5 and adjusting the metal stockpile for debris stockpiling.
- Removing asbestos from the floor and pipes in the basement of the south section of Building No. 3.
- Stockpiling ACM debris from the old foundations of Building Nos. 4 and 5.

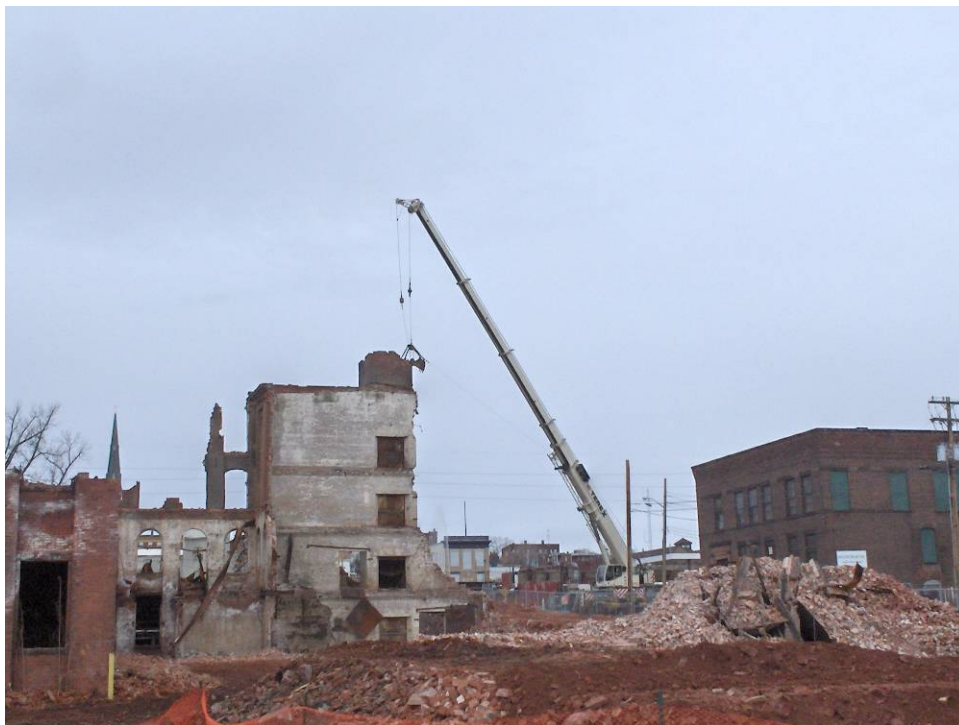
**SCENE:** View of Building No. 4 during demolition work. Photograph taken facing north.

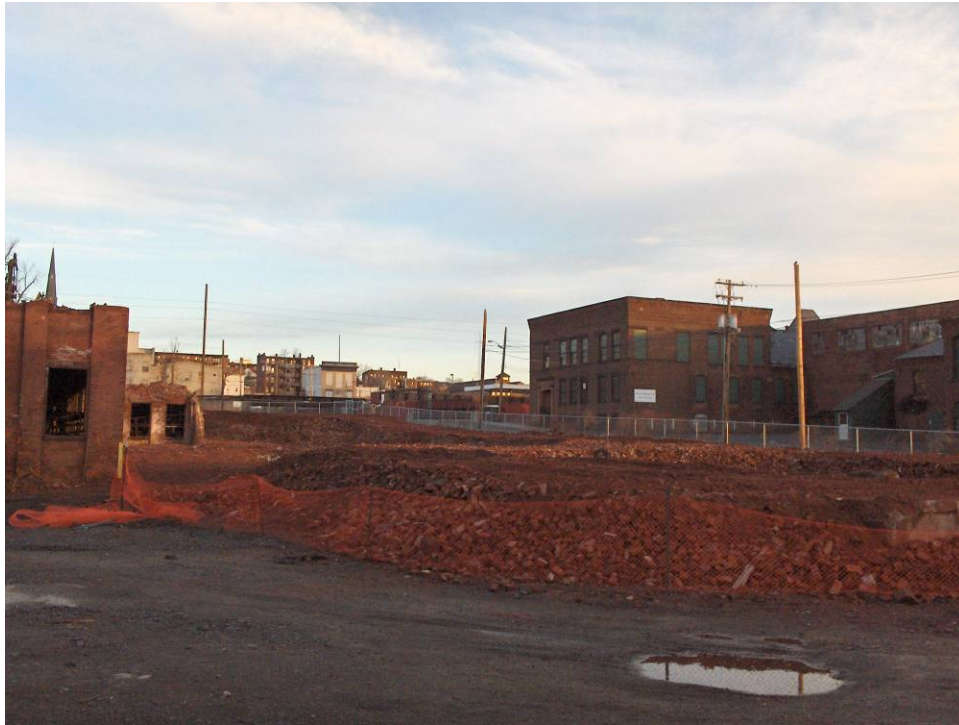
**SCENE:** View of location of former Building No. 4 following demolition. Photograph taken facing north.

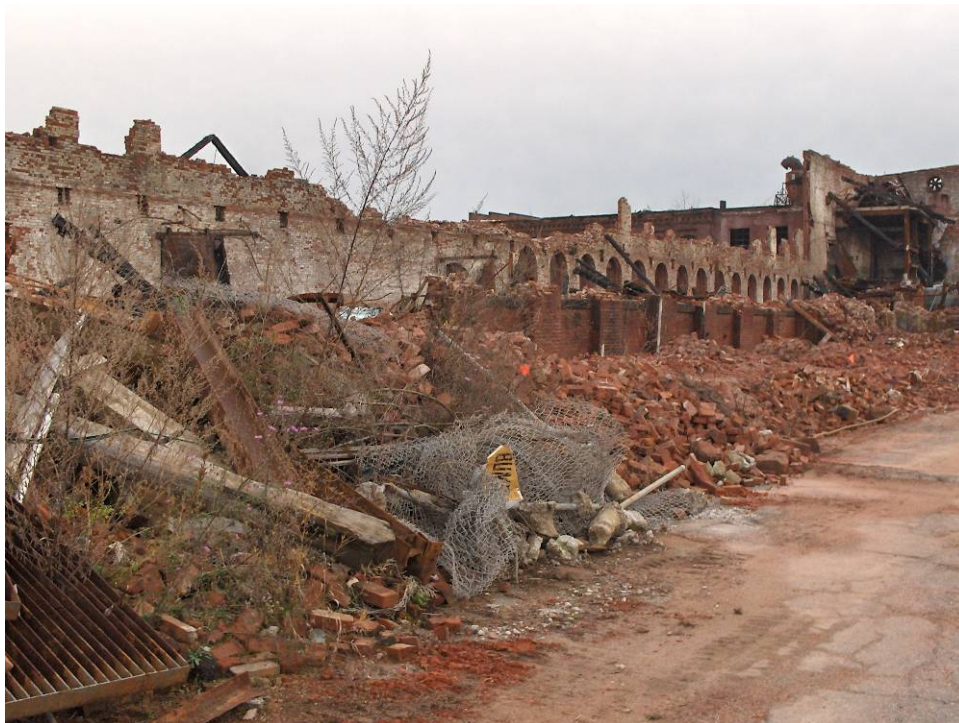
**SCENE:** View of the remains of Building No. 5 at the start of the removal project. Photograph taken facing south.

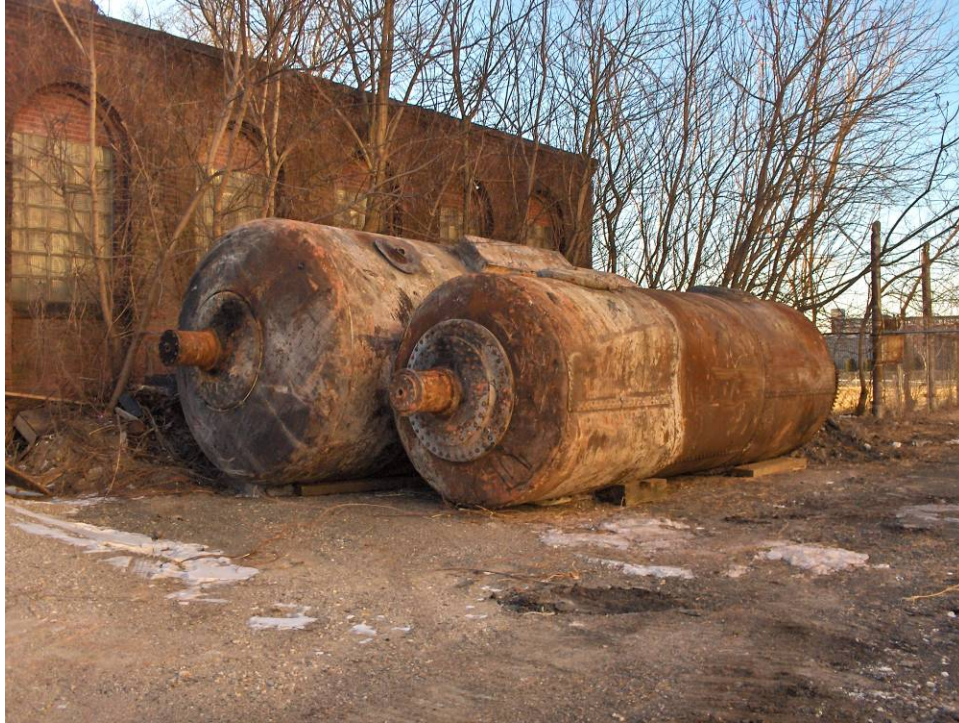
**SCENE:** View of the two tanks removed from the footprint of Building No. 5. The smaller tank required ACM removal. Photograph taken facing south.

- Conducting perimeter air sampling.
- Removing scrap metal from around and within the old foundation of Building No. 5 and stockpiling it in the middle of the building foundation.
- Removing asbestos from the floor and pipes in the basement and from the first floor of the southwest section of Building No. 3.
- Completing asbestos removal from the basement of Building No. 2 and sealing all access points.
- Conducting a bid walk with demolition subcontractors.
- Removing two tanks from the old foundation of Building No. 5.

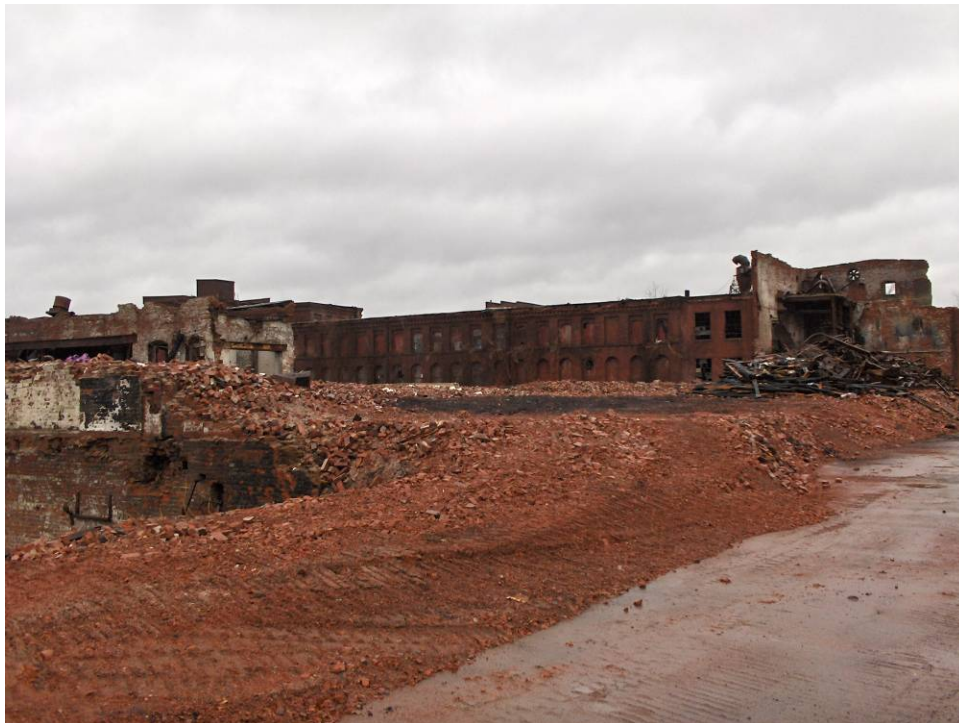
**SCENE:** View of Building No. 5 following demolition, and after steel stockpiling was completed. Photograph taken facing south.
